Flood Control Project Maintenance**2013 Structure Summary Report****Overall Unit and Item Ratings****Turlock Irrigation District Gomes Lake****Gomes Lake Pumping Plant**

Flood Control Project Maintenance**Unit Cover Sheet****2013 Pumping Plant Inspection Results****Turlock Irrigation District Gomes Lake**

Pumping Plant
Gomes Lake Pumping Plant

Pumping Plant Rating	A
Date of Inspection	08/01/2013
DWR Inspector	Pavel Kazi
Accompanied By	Robert Caetano TID

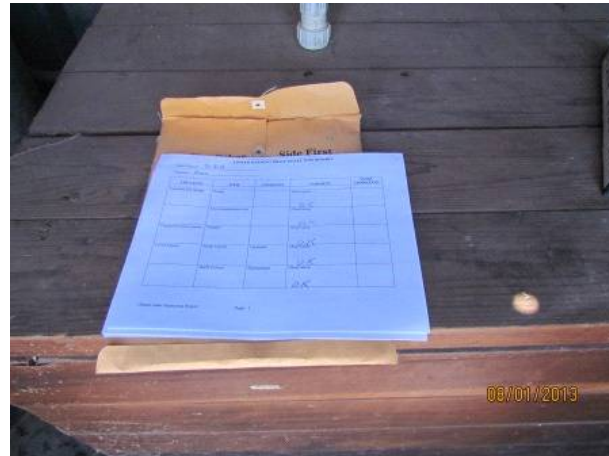
Levee Mile Report Line	1
Start Levee Mile	0.00
End Levee Mile	0.00
Location	
Category	Pump Stations
Item	Operating Log

View of the operating log.

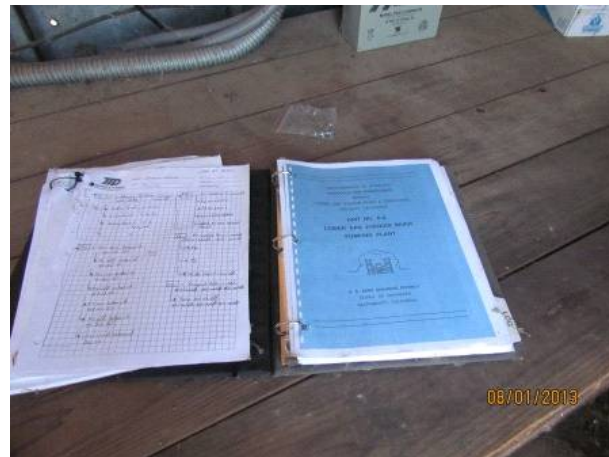
Levee Mile Report Line	2
Start Levee Mile	0.00
End Levee Mile	0.00
Location	
Category	Pump Stations
Item	Operation & Maintenance Manual

View of the O&M manual inside the plant.

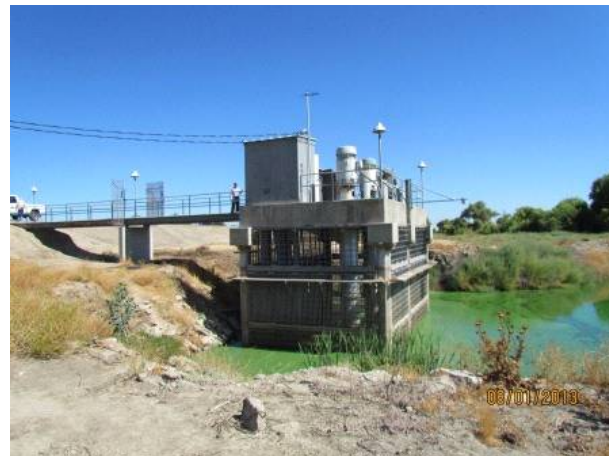
Levee Mile Report Line	3
Start Levee Mile	0.00
End Levee Mile	0.00
Location	
Category	Pump Stations
Item	Plant Building

View of the pumping plant.

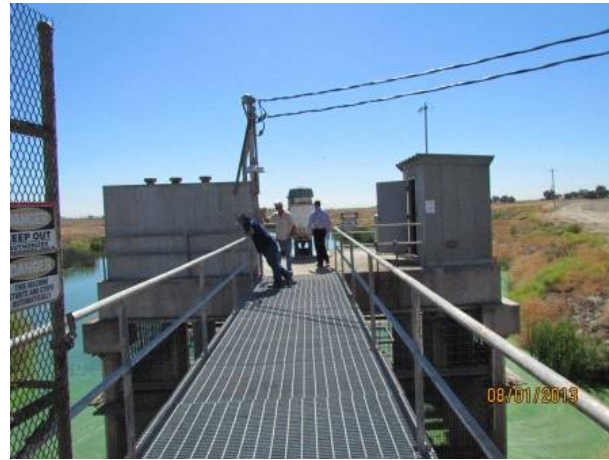
Levee Mile Report Line	5
Start Levee Mile	0.00
End Levee Mile	0.00
Location	
Category	Pump Stations
Item	Safety

View of the guard rails around the pumping plant.

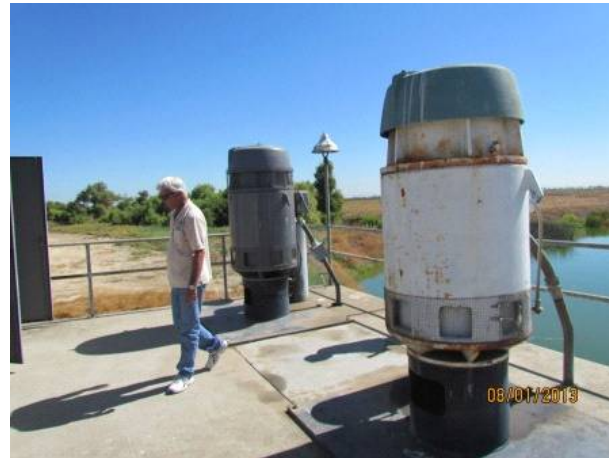
Levee Mile Report Line	7
Start Levee Mile	0.00
End Levee Mile	0.00
Location	
Category	Pump Stations
Item	Pumps

View of the pumps.

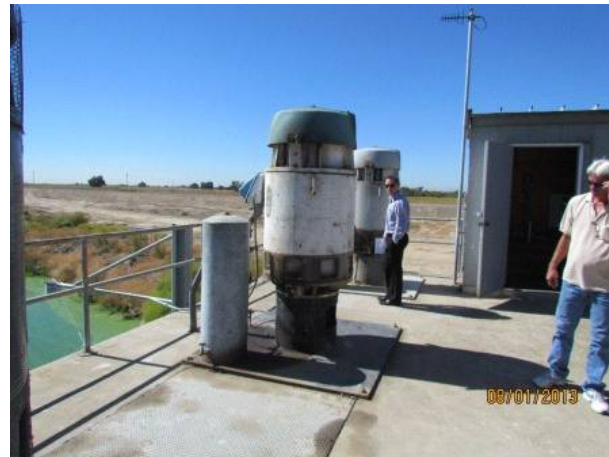
Levee Mile Report Line	7
Start Levee Mile	0.00
End Levee Mile	0.00
Location	
Category	Pump Stations
Item	Pumps

Alternate view of the pumps.

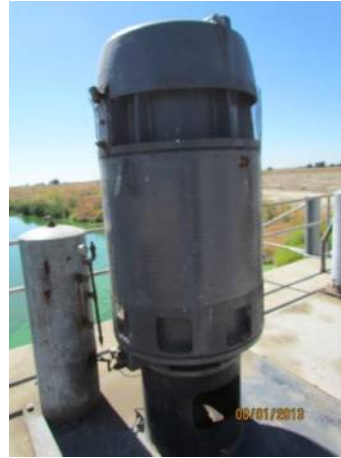
Levee Mile Report Line	7
Start Levee Mile	0.00
End Levee Mile	0.00
Location	
Category	Pump Stations
Item	Pumps

View of one of the pumps.

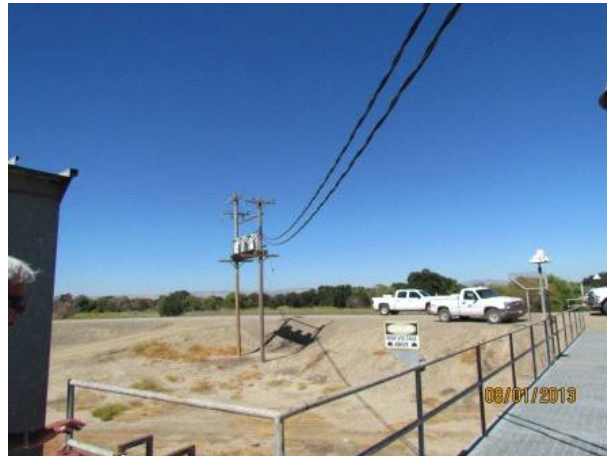
Levee Mile Report Line	8
Start Levee Mile	0.00
End Levee Mile	0.00
Location	
Category	Pump Stations
Item	Power

8	0.00	0.00	Pump Stations	Power		A	Item inspected visually only. Item was not operated during the inspection. Inspector Comments: The power source for this plant was delivered by the power grid rather than a generator and it appeared to be adequate and reliable.	37.481567 ° -121.046617 °	37.481567 ° -121.046617 °	8 Y
9	0.00	0.00	Pump Stations	Motors, Engines, Fans & Gear Reducers		N	Item inspected visually only. Item was not operated during the inspection. Inspector Comments: Other than the pump, no gear reducer or any other mechanical motor was present at the plant.	37.481567 ° -121.046617 °	37.481567 ° -121.046617 °	10 Y
10	0.00	0.00	Pump Stations	Pump Control Systems		A	Item inspected visually only. Item was not operated during the inspection. Inspector Comments: The pump control system was operational and appeared to be free of any damage or corrosion.	37.481567 ° -121.046617 °	37.481567 ° -121.046617 °	11 Y

View of the power source at the plant.

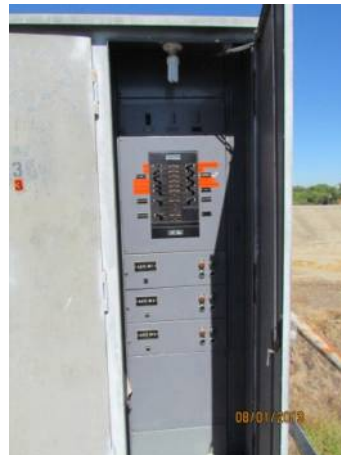
Levee Mile Report Line	10
Start Levee Mile	0.00
End Levee Mile	0.00
Location	
Category	Pump Stations
Item	Pump Control Systems

View of the power switch system.

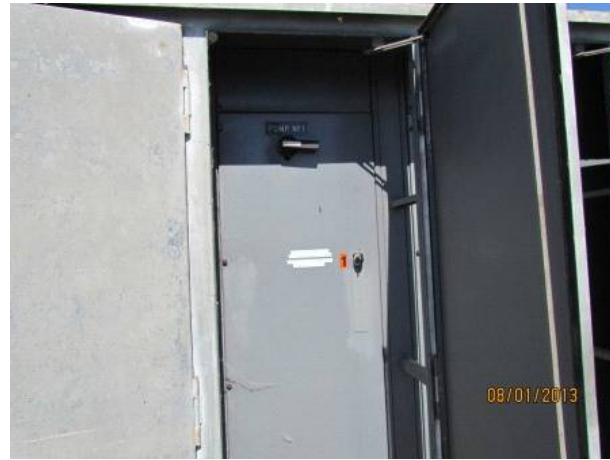
Levee Mile Report Line	10
Start Levee Mile	0.00
End Levee Mile	0.00
Location	
Category	Pump Stations
Item	Pump Control Systems

View of the one of the pump power control box.

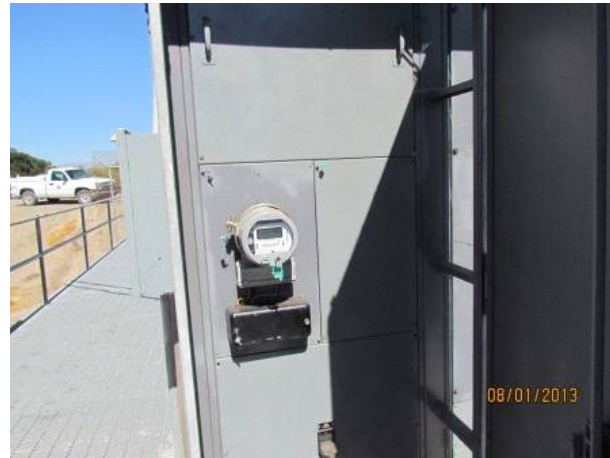
Levee Mile Report Line	10
Start Levee Mile	0.00
End Levee Mile	0.00
Location	
Category	Pump Stations
Item	Pump Control Systems

View of the power meter.

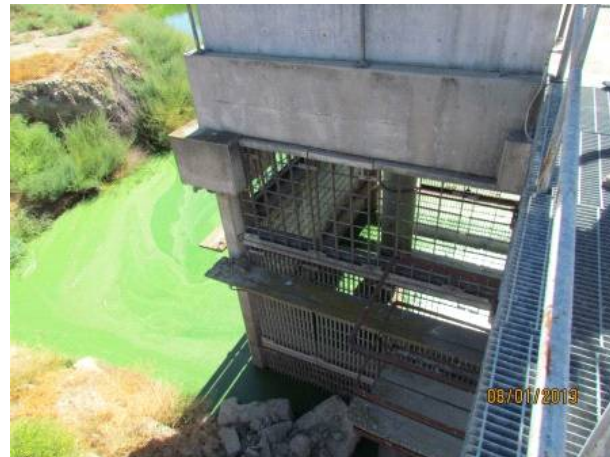
Levee Mile Report Line	11
Start Levee Mile	0.00
End Levee Mile	0.00
Location	
Category	Pump Stations
Item	Sumps/Wet Well

View of the wet well.

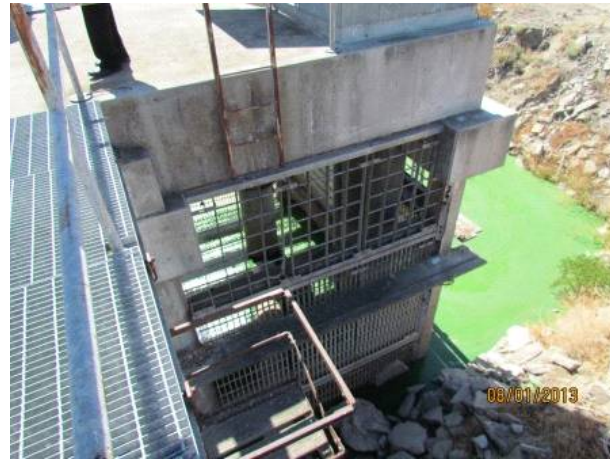
Levee Mile Report Line	11
Start Levee Mile	0.00
End Levee Mile	0.00
Location	
Category	Pump Stations
Item	Sumps/Wet Well

View of the wet well.

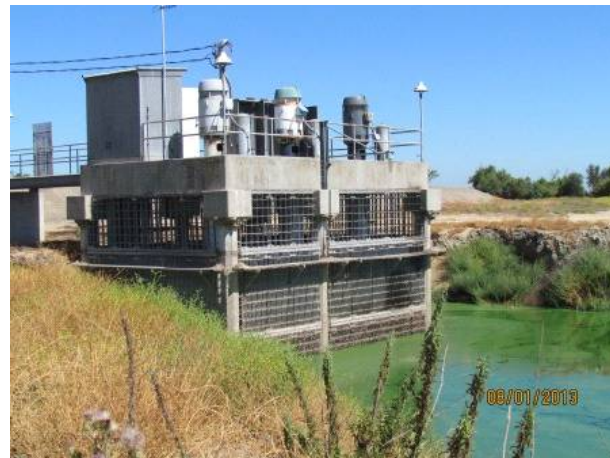
Levee Mile Report Line	12
Start Levee Mile	0.00
End Levee Mile	0.00
Location	
Category	Pump Stations
Item	Trash Racks

View of the trash racks.

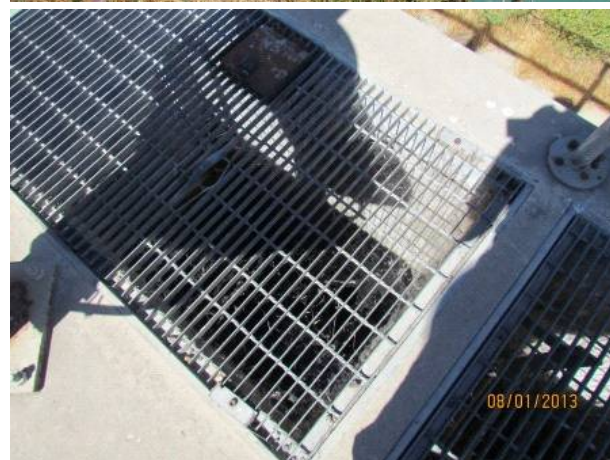
Levee Mile Report Line	14
Start Levee Mile	0.00
End Levee Mile	0.00
Location	
Category	Pump Stations
Item	Sluice / Slide Gates

14	0.00	0.00	Pump Stations	Sluice / Slide Gates		A	Item inspected visually only. Item was not operated during the inspection. Inspector Comments: The slide gates were free of any debris and appeared to be in good working condition.	37.481567 ° -121.046617 °	37.481567 ° -121.046617 °	15 Y
15	0.00	0.00	Pump Stations	Electric Gate Operators		A	Item inspected visually only. Item was not operated during the inspection. Inspector Comments: The electric gate operators were in good working condition.	37.481567 ° -121.046617 °	37.481567 ° -121.046617 °	16 Y
16	0.00	0.00	Pump Stations	Manual Gate Operators		A	Item inspected visually only. Item was not operated during the inspection. Inspector Comments: Manual gate operators appeared to be operational and capable of opening and closing the gate properly.	37.481567 ° -121.046617 °	37.481567 ° -121.046617 °	17 Y
17	0.00	0.00	Pump Stations	Other Metallic Items		A	Item inspected visually only. Item was not operated during the inspection. Inspector Comments: All the other metal parts in the plant appeared to be in good condition.	37.481567 ° -121.046617 °	37.481567 ° -121.046617 °	18 Y

View of the slide gate from the top of the structure.

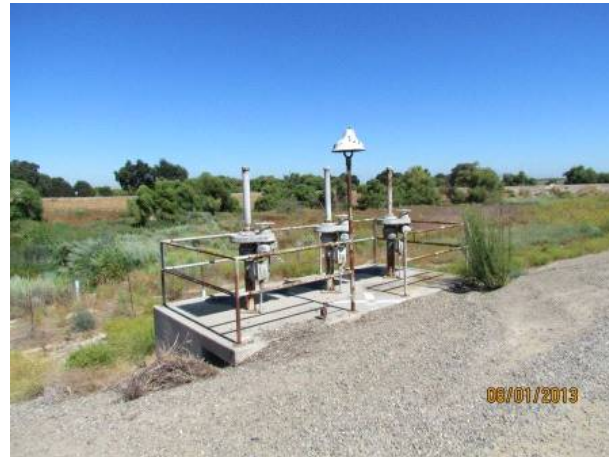
Levee Mile Report Line	16
Start Levee Mile	0.00
End Levee Mile	0.00
Location	
Category	Pump Stations
Item	Manual Gate Operators

View of the manual gates.

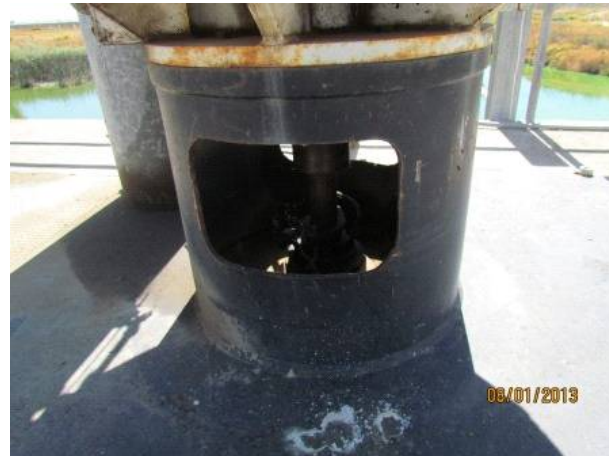
Levee Mile Report Line	17
Start Levee Mile	0.00
End Levee Mile	0.00
Location	
Category	Pump Stations
Item	Other Metallic Items

Detail view of bottom of a pump.

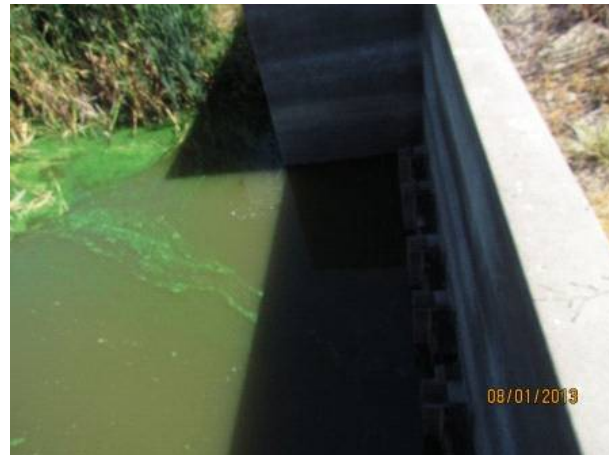
Levee Mile Report Line	18
Start Levee Mile	0.00
End Levee Mile	0.00
Location	
Category	Pump Stations
Item	Flap Gates

18	0.00	0.00	Pump Stations	Flap Gates		A	Item inspected visually only. Item was not operated during the inspection. Inspector Comments: The flap gates appeared to be in good working condition and capable of performing as intended.	37.481567 ° -121.046617 °	37.481567 ° -121.046617 °	19 Y
19	0.00	0.00	Pump Stations	Closure Structures		N	Item inspected visually only. Item was not operated during the inspection. Inspector Comments: No closure structure exists at this plant.	37.481567 ° -121.046617 °	37.481567 ° -121.046617 °	20 Y
20	0.00	0.00	Pump Stations	Security Fencing		A	Item inspected visually only. Item was not operated during the inspection. Inspector Comments: The security fencing appeared to be in good condition and should provide protection against unauthorized access.	37.481567 ° -121.046617 °	37.481567 ° -121.046617 °	21 Y

View of the flap gates.

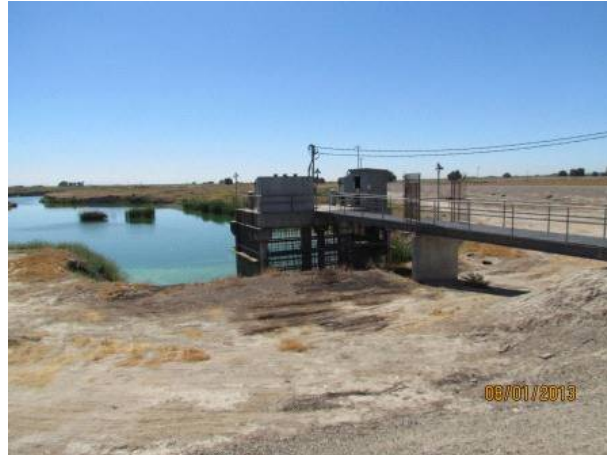
Levee Mile Report Line	20
Start Levee Mile	0.00
End Levee Mile	0.00
Location	
Category	Pump Stations
Item	Security Fencing

View of the fences around the pumping plant.
